BD Ford Screamer Drop-in Replacement 2003-07 Ford 6.0L

1045820	61mm	Stage 1
1045821	63mm	Stage 2

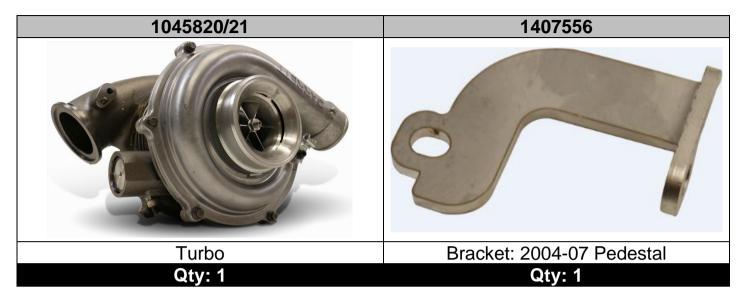
Kit Contents - 1032130

1400284	1400283	2485006
0	0	000
O-Ring; 12.29mmx3.53mm	O-Ring; #210	Gasket; 6.0L
Qty: 1	Qty: 2	Qty: 1

FT-11115722	FT-11115717	FT-11115725	FT-11115714
Bolt; M8x16	Bolt; M6x20	Bolt; M830	Bolt; M6x10
Qty: 2	Qty: 1	Qty: 3	Qty: 1

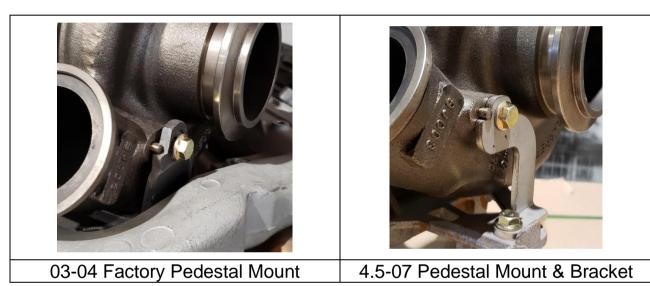
BD's Ford 6.0L Screamer utilizes one turbine housing for all 2003-2007 pickups. Bracket part number 1407556 is used to mount on trucks 2004.5-2007. Early model trucks will not need to use this bracket.

Use bolts FT-11115722 and bracket 1407556 on the rearmost mounting flange on the turbine housing. Hand thread a bolt through the 1407556 bracket and into the pedestal to mount it prior to turbo installation. Remember to tighten all mounting bolts after turbo is mounted (23 ft-lbs). Mount the bracket to the turbo using the bolting location as pictured.
